SKELF BIKE PARK PROPOSAL

BRAIDWOODS

WOODLAND AND TREE IMPACT ASSESSMENT

**Produced :-
November 2015**

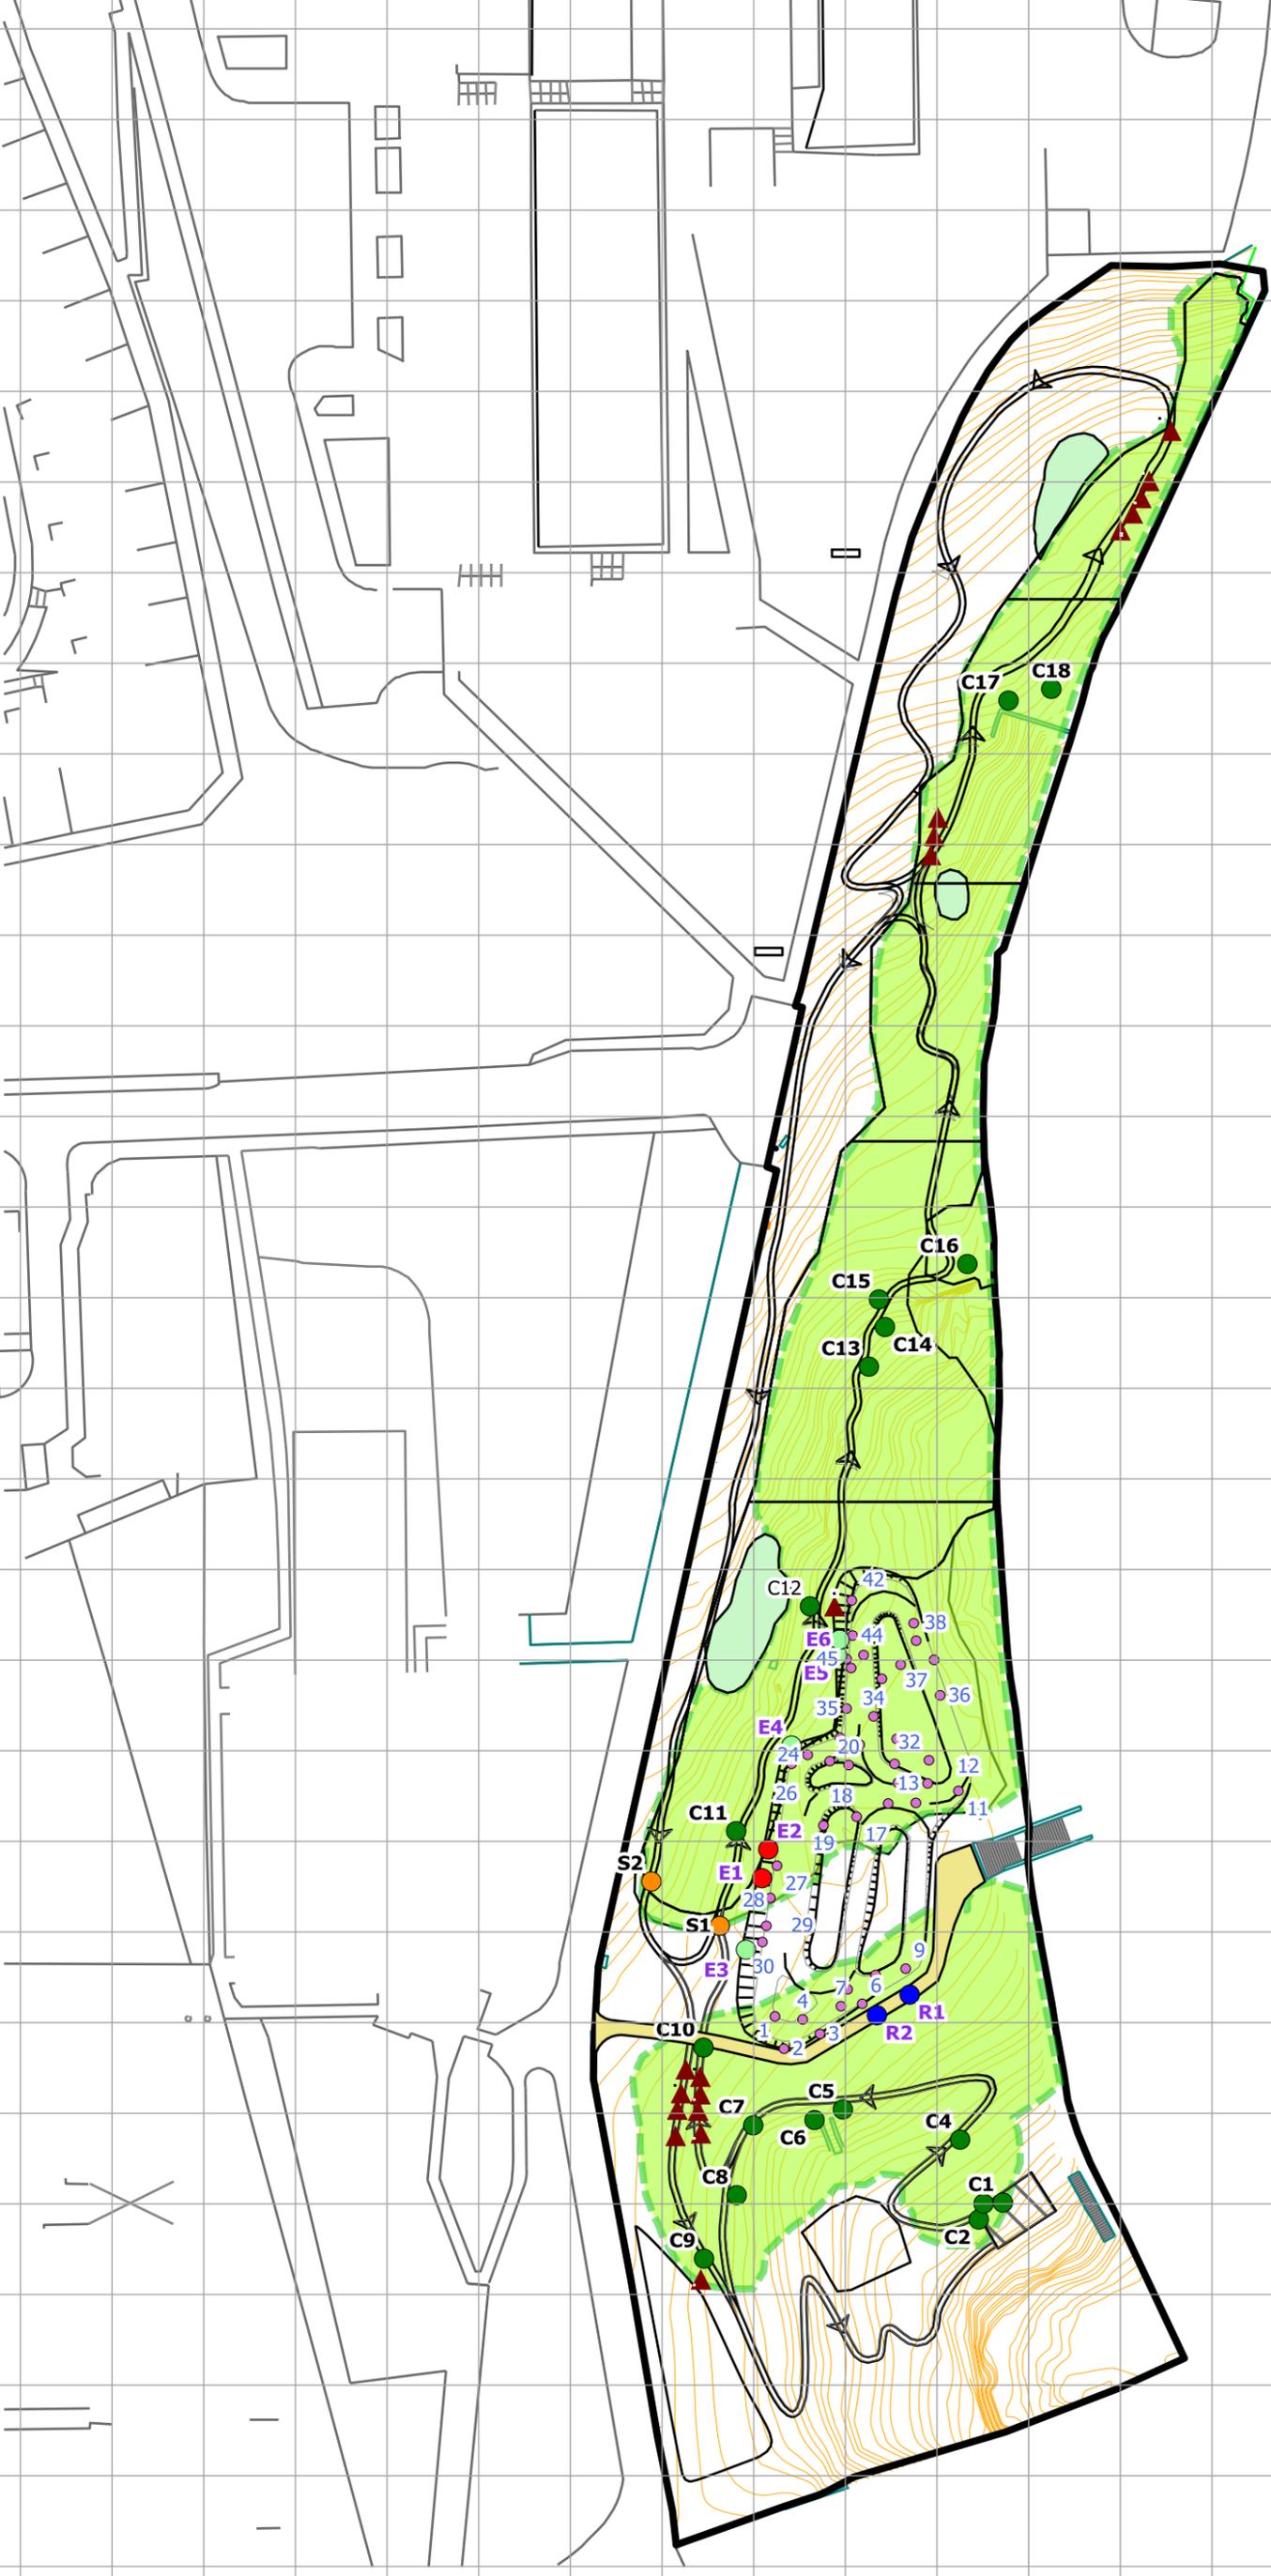
MAP 2 - Proposed Tree Works v2
Scale - 1:750 @ A3
Date - September 2015

In order to assess the actual tree removals involved, the footprint of the Pump Track was marked out on site, and all trees within, or in close proximity to, the Pump Track were numbered, surveyed, assessed, and recorded. They were also marked with a yellow dot (within the Pump Track area) or a green cross (within the embankment area). These details are shown in Appendix 1, while the approximate locations of the trees is shown on Map 2

In total, 50 trees will be removed. Of these, 8 have been categorised as being 'U' i.e. trees of very low quality, with the remainder being category C, trees of low quality. The majority of the trees are either Norway maple or lime (see table 2 below). In line with the overall nature of the woodland most trees within the affected area are between 25cm diameter, and 12-14m in height, with the largest tree being 41cm diameter, and the tallest 16m in height.

The proposed routes have been walked, and trees which may have to be removed to facilitate both the trail construction and use by cyclists have been numbered, mapped, surveyed, assessed, and recorded. They were also marked with a white dot. These details are shown in Appendix 1, while the approximate locations of the trees is shown on Map 2. In total, 18 trees will be removed. Of these, 4 have been categorised as being 'U' i.e. trees of very low quality, with the remainder being category C, trees of low quality. The majority of the trees are either Norway maple or ash (see table 2 below). Most trees are between 15-20cm diameter, and 10-12m in height, with the largest tree being 25cm diameter, and the tallest 14m in height.

The proposed route has been walked, and trees which may have to be removed to facilitate both the path construction and use have been numbered, mapped, surveyed, assessed, and recorded. They were also marked with a green band. These details are shown in Appendix 1, while the approximate locations of the trees is shown on Map 2.

- Four trees on the boundary of the embankment have been identified as having the potential to be retained, and to fulfil screening and amenity functions on completion of the works. These trees are detailed in the Tree Survey Table and their approximate locations are shown on Map 2. These trees should be protected in line with BS 2837:2012 in as far as is feasible. However, due to their proximity to the embankment that will be created it will not be feasible to erect a protective fence outwith of these trees's root protection area, but a temporary fence will be erected as detailed below.

- Prior to works commencing a temporary post and wire fence or 'Heras' type fence, should be erected and maintained on the boundary of the Pump Track, with works being confined within the enclosed area.
